The Airbus Safety Magazine

01 | January 2005 |

Go-Arounds at Addis Ababa due VOR Reception Problems

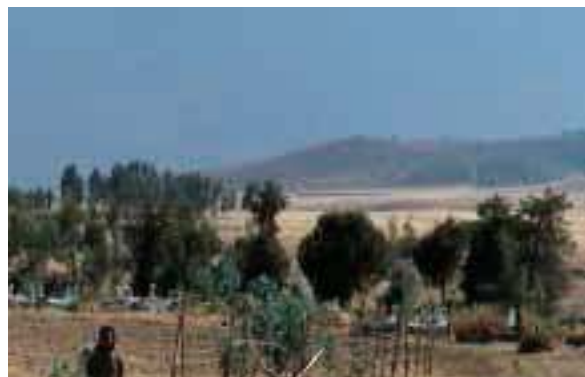
This photograph shows the NW to SE ridge running down towards the approach path. It was taken from near the village of Leghedadi 10nm NW of the airport looking WSW from a range of approximately 5nm.

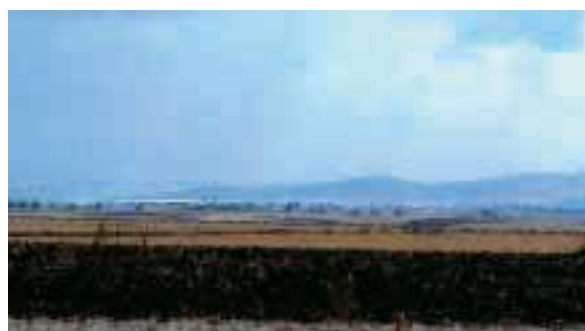
This picture shows the same ridge from a range of about 8nm from the NW of Leghedadi.

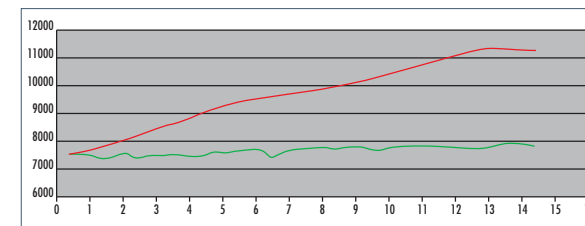
Figure 1 shows the profiles for the approach carried out on the return from Djibouti which was carried out visually. The terrain profile is typical for a correct approach path with the characteristic gentle slope of the plain from west to east. Other characteristic features are the river valley at 6.5D and the double depression on the final approach to the threshold.

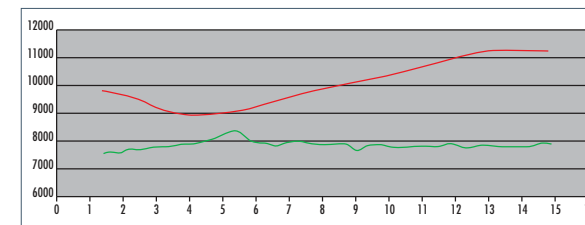
Figure 2 shows the profiles for the first approach at HAAB. Notable points are the non-sloping nature of the terrain between 15nm and 6nm and the high point at just over 5nm. There is also a marked valley at 9nm and a lesser one at 6.5nm.

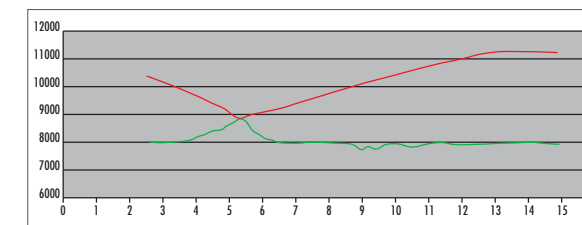
Figure 3 shows the profiles for the second approach at HAAB. Here, the notable points are again the flat terrain between 15nm and 7.5nm and the high point at just over 5nm. The river valley is still apparent at 9nm, but has split into two. The terrain clearance at the point of go-around is 55'.

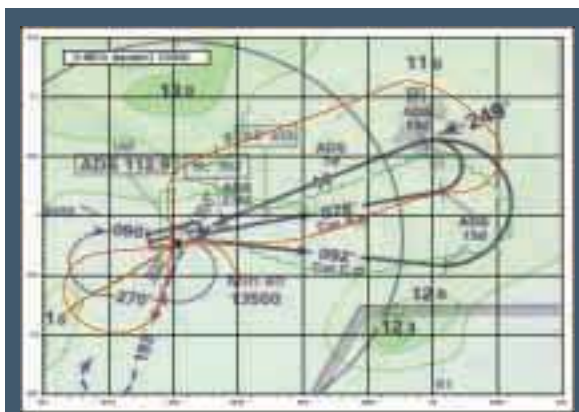
Figure 4

- During the outbound leg of the procedure, the VOR bearing information correlated with the GPS derived FMGC data on the Navigation Display (ND).
- As the aircraft turned left to intercept the 249°M track inbound to the VOR, the beam bar initially moved in as expected to near centre.
- As the wings were levelled on a heading that should have followed the correct track, the beam bar moved back out to the right and settled at about half to two thirds full scale deflection.
- The crew flew by visual reference to the runway using the GPS derived navigation data to follow the correct inbound track and the VOR indication remained steady at the deflection stated above.
- At about 3.5D, the beam bar quickly moved back to the central position.

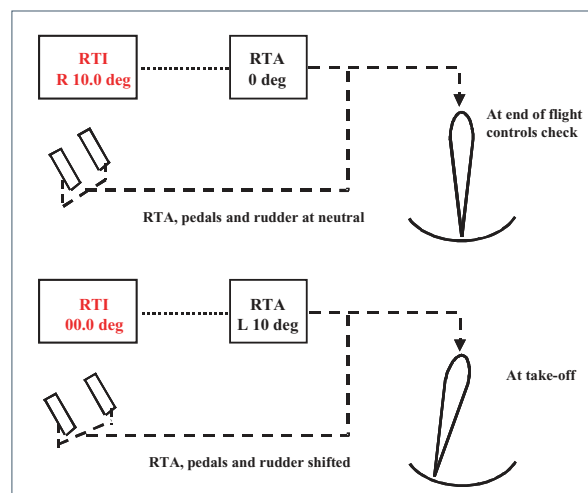
Rudder trim actuator (RTA) had to be at neutral also. Indication was erroneous.

Rudder trim indication was manually brought back to neutral with no further check. This shifted the rudder, the rudder trim actuator and the pedals out of neutral.

Figure 2 : incorrect rudder trim indication

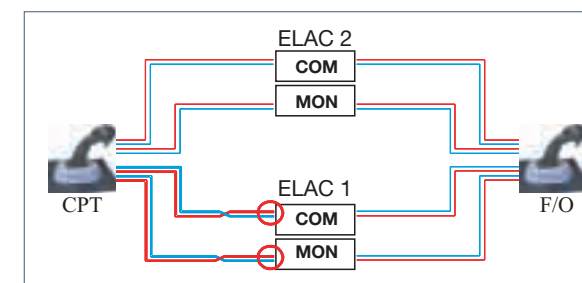
Upon troubleshooting, a maintenance error was found. A wiring inversion had been made between the transducer unit of Captain roll sidestick and ELAC 1, on both the COMMAND & MONITOR channel. With this double inversion, ELAC 1 was receiving consistent signals, and thus could not detect the anomaly and could not trigger a warning to the crew (Figure 3).

Figure 3: Cross connection of sidestick roll signals to F/CTL computer

The functional check required after performing AMM tasks had partially been performed on the F/O side only, and thus the anomaly was not detected by mechanics. Crew missed the last opportunity to detect it by not carefully performing the existing SOP F/CTL Check.

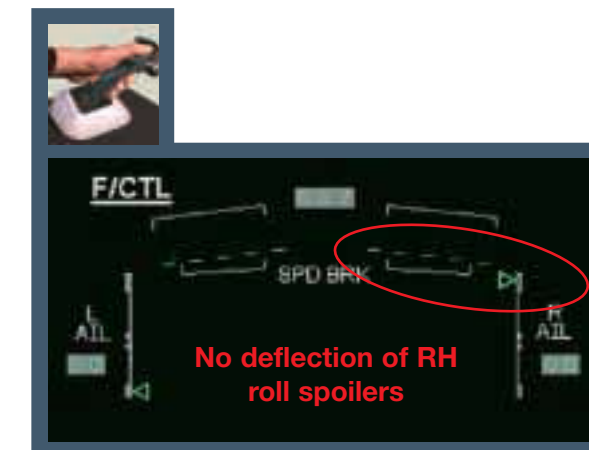
During a previous maintenance task, R/H spoilers 2 to 5 were left in the maintenance position. After lift-off, they deployed to the zero hinge moment positions and would not respond to inputs.

Figure 4: Lack of response from RH spoilers to sidestick inputs

Preventive instructions have been added in AMM, and monitoring has been improved to trigger an ECAM warning in such condition. But it could also have been detected by carefully performing the existing SOP F/CTL Check (Figure 4).

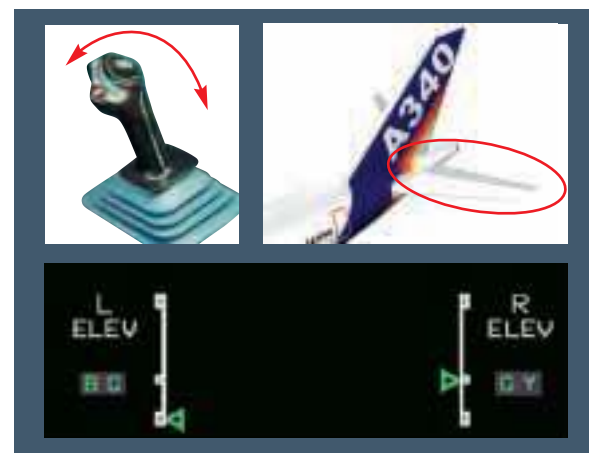
Figure 5

A few events of this kind have been experienced with aircraft of the A340 family. The crew detected during the pre-flight F/CTL check that one elevator was stuck down (Figure 5). The loss of the elevator control was not indicated to the crew by any warning.

These events resulted from failure of the servo-control in damping mode failed. Investigating these events has allowed definition of modifications to both the servocontrols and the F/CTL computers in order to prevent similar events. Appropriate ECAM warnings are triggered for crew annunciation. For these events, detection was ensured by carefully performing the existing SOP F/CTL Check only. Additional information about these event is available with

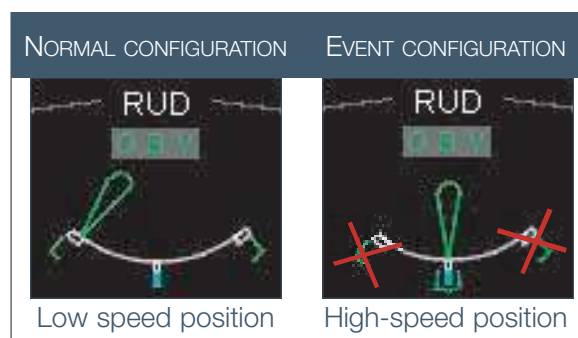
The Rudder Travel Limitation Unit (RTL) had failed closed in the high-speed configuration. The ECAM warning "F/CTL TRAVEL LIM FAULT" dedicated to the monitoring of the RTL position was not displayed.

Indeed, at that time, FCSC which is the computer that controls the RTL and PTLU did not monitor their behaviour during phases when they are not electrically supplied and thus not supposed to move. However the RTL system failed and RTL closed during such a phase of no monitoring on ground. Monitoring has since been reviewed.

Figure 6: Full rudder deflection not achieved

The failure was thus detected only by performing the existing SOP F/CTL Check, and the right decision to return to the gate could be taken.

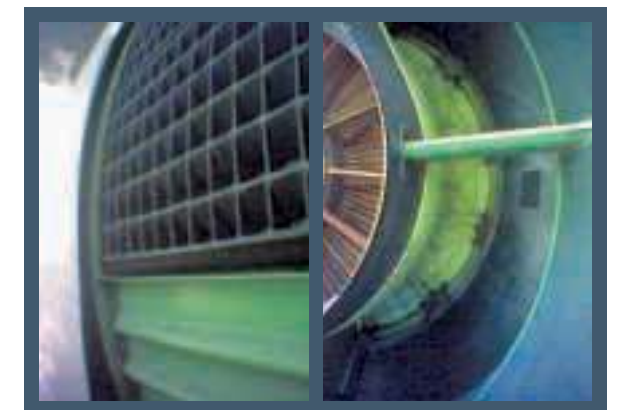
Figure 1

- Upon landing, the engine N° 1 reverser was found almost fully deployed.

- The thrust reverser sleeve locking pins (2) were not found, while the lock-out assembly was intact.
- After opening the fan cowls, both locking actuators were found lock wired in the unlock position. The HCU was properly deactivated.

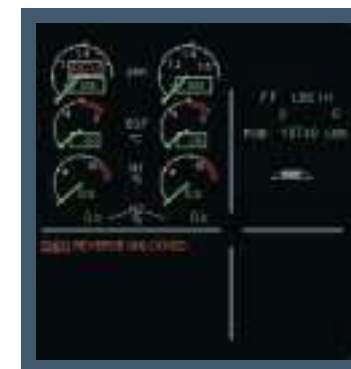
Figure 2

Prior to engine start, the ECAM warning “ ENGX REVERSE UNLOCKED” was annunciated.

According to information received, maintenance personnel cancelled the “ENGX REVERSE UNLOCKED” message through the “EMER/CAN” button.

In addition, the "EMER/CANC" button should only be utilized to kill a permanent spurious warning.

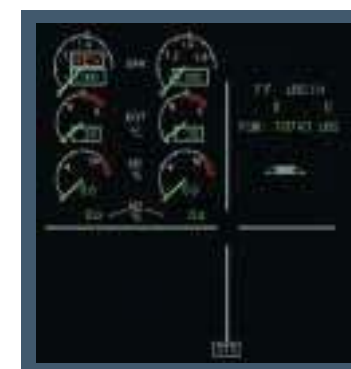
Figure 3

Upon engine start, the “ENGX REVERSE UNLOCKED” warning was then displayed under cancelled cautions, while the ECAM showed “REV” Amber in EPR gauge and “STS” indication.

The "ENGX REVERSE UNLOCKED" and the "REV" Amber messages should not be present on ECAM following a proper thrust reverser deactivation. **They are both NO DISPATCH warnings.**

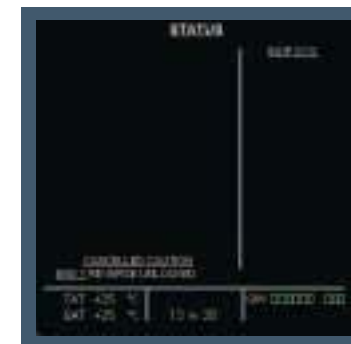
Figure 4

However, the aircraft was dispatched with the thrust reverser unlocked and free to move under aerodynamic forces.
