The Airbus Safety Magazine

01 | January 2005 |

Go-Arounds at Addis Ababa due VOR Reception Problems

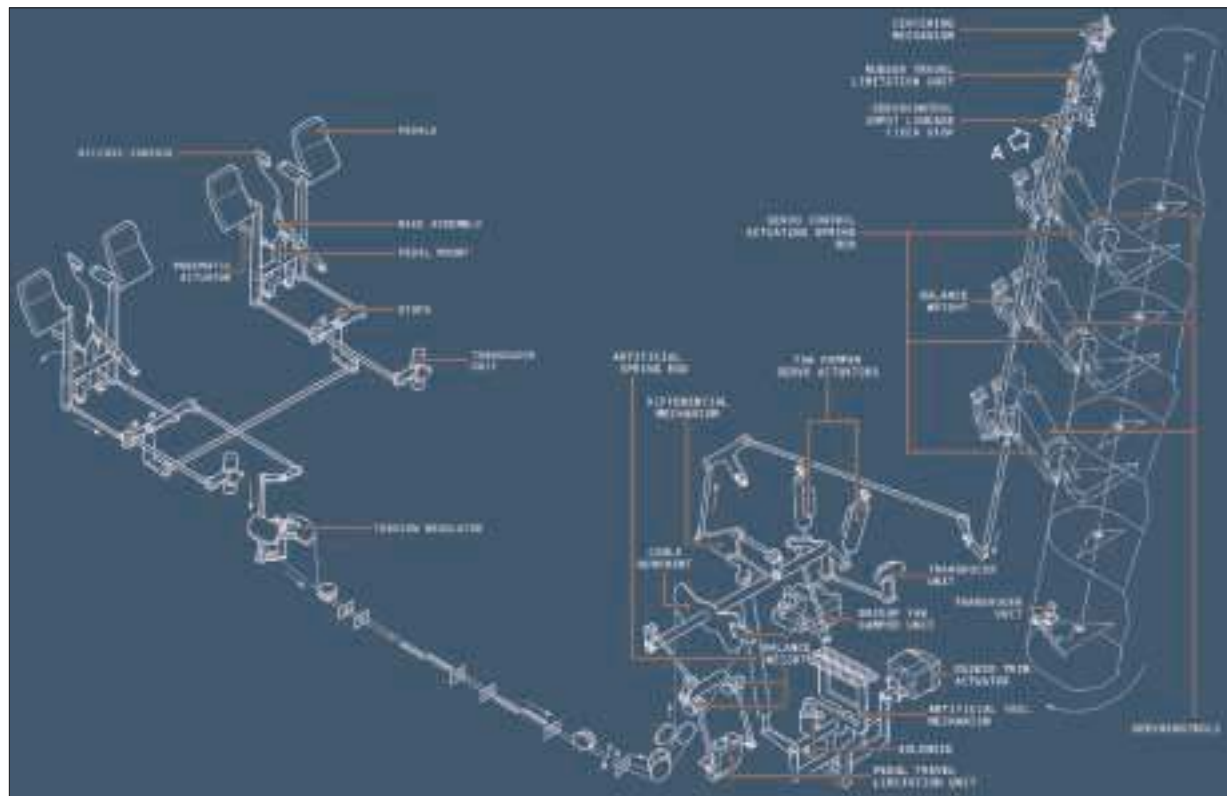
Figure 1 : A330 moder system schematic

On any Airbus aircraft, the F/CTL check involves the elevators, ailerons, spoilers and rudder control systems. Not only the components activated with the control wheel, control column and pedals, but the whole system. Let us refer to figure 1 and take the rudder axis of an A310 as an example in order to illustrate this comment.

The F/CTL check is thus not limited to the relationship in between the servocontrols, observed with the surface position indicators, and the controls at cockpit. The whole system is checked.

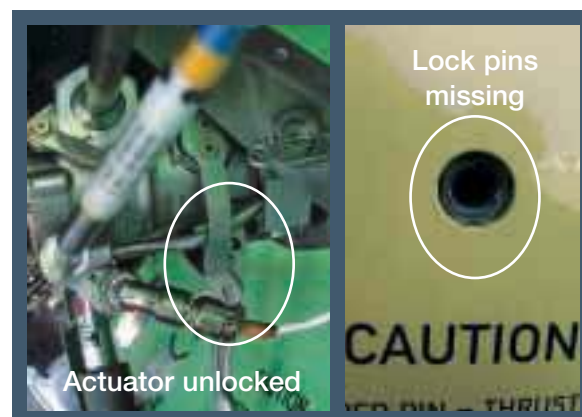
- The HCU deactivation was done properly following the AMM procedure:
 - “A. Deactivation of the Thrust Reverser HCU” procedure.
- The following AMM procedure steps were not performed , because it was not possible to do so while the thrust reverser actuators were lock wired in the unlocked position:
 - “B. Manually move the translating sleeves to the fully retracted position”
 - “C. Lock the Left and the Right Translating sleeves”
- Finally the last AMM procedure step was not done.
 - “D. Put the locking actuators in the locked position”

Due to the combination of having:

- The HCU deactivated (leading to no hydraulic power to the actuators)
- And the actuators not locked
- And the lock-out bolts not properly installed on the translating sleeves,

Furthermore, only the required tooling must be used (appropriate locking pins,...)

Finally, "ENG X REVERSE UNLOCKED" warning should not be displayed following reverser deactivation.

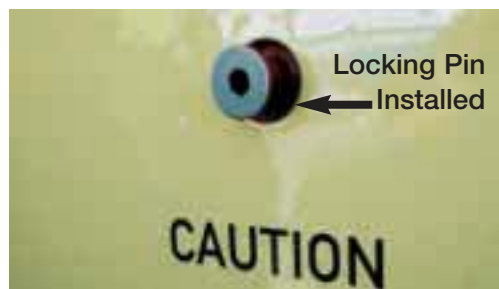
Figure 10: Deactivated Flight Condition

The "ENGX REVERSE UNLOCKED" and the "REV" Amber messages should not be present on ECAM following a proper thrust reverser deactivation. **They are both NO DISPATCH warnings.**

In addition, the "EMER/CANC" button should only be utilized to kill a permanent spurious warning.
